Centennial Park Retaining Walls
18 Park Drive, Petawawa

RISK SUMMARY

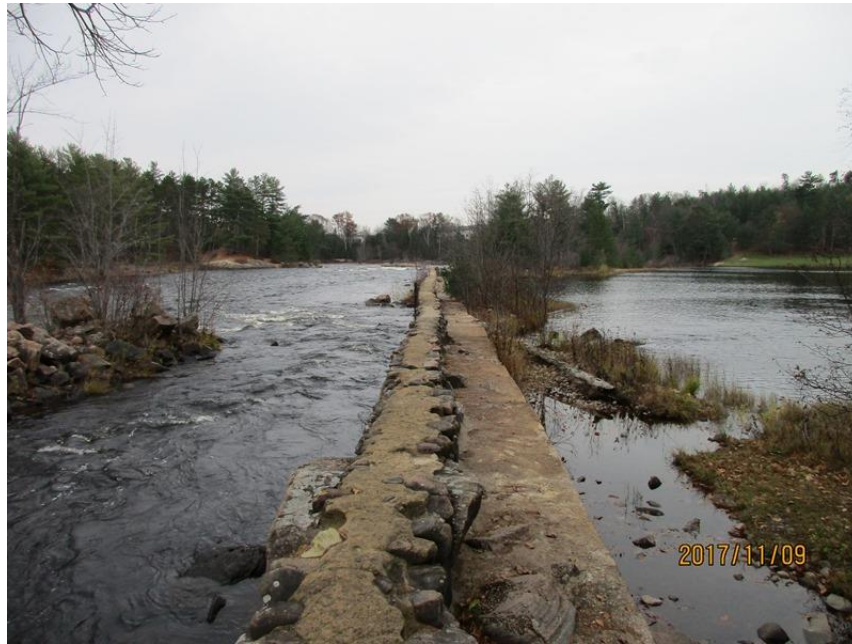
Rock Wall (Looking East towards the Island)

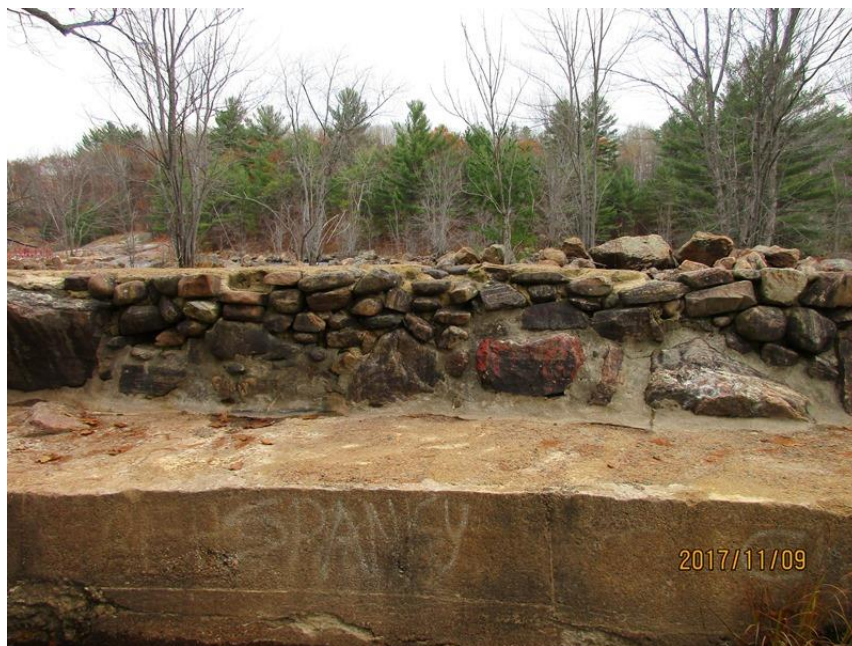
Rock Wall (Partial Elevation View)

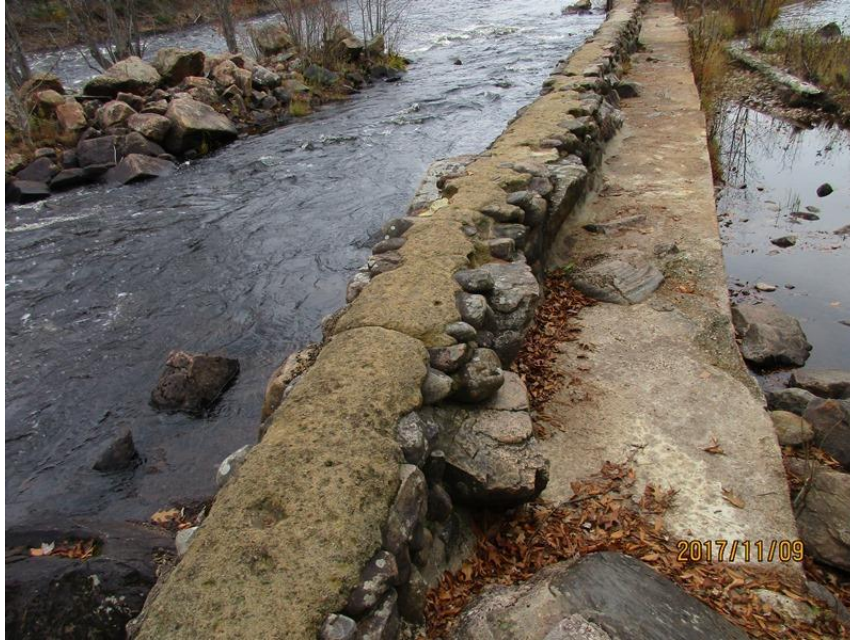
- 17** - Re-grouting the rock wall and repointing/resurfacing the walkway surface does not solve the liability issue. The west wall is not high enough, has numerous trip and fall hazards, has a walking surface which is narrow and uneven and undulating and is considered unsafe. Since the wall is rock and grout a potential breach is possible with the higher river water levels and forces.

- 18** - There are also several holes and depressions in the concrete walking surface.
- 19** - Although there are no known reported accidents or fatalities reported in the last 50 years, it is foreseeable that it will happen. If an incident occurred, the courts would most likely apply the "prudent person" scenario.

Rock Wall Walking Surface - and Trip and Fall Hazards

2 - If the decision is to restrict access to the walls which is what we would recommend as the most cost effective solution, then signage and fence barriers can be installed at the entrances to the walls. The walls are currently an attractive nuisance and in the current litigious climate there would be little defence to liability charges. These fence barriers are envisioned to be similar to the barriers uses at the bottom of water dam discharges. The fences would be non-climbable with wing walls that are welded in order to prevent people circumventing the barrier. The barriers would allow the surge of water to pass through.

3 - If the decision is to allow residents access to the walls, then we would recommend that the walking surface follow sidewalk (Minimum Maintenance Standards –MMS) standards and be wide enough and have guards on both sides conforming to Ministry of Labour occupational health and safety regulation for industrial establishments. For the east wall, precast walkways with guards could be added on top of the existing wall by drilling anchors into the current concrete. The walkways would also be level and therefore would be somewhat of an eyesore (not aesthetically pleasing) since the concrete wall below it slopes toward the east by a large margin. However this type of solution would not be practical for the rock wall on the west side, since the rock wall does not have a homogenous consistency in order to be able to have a structurally sound composite element.

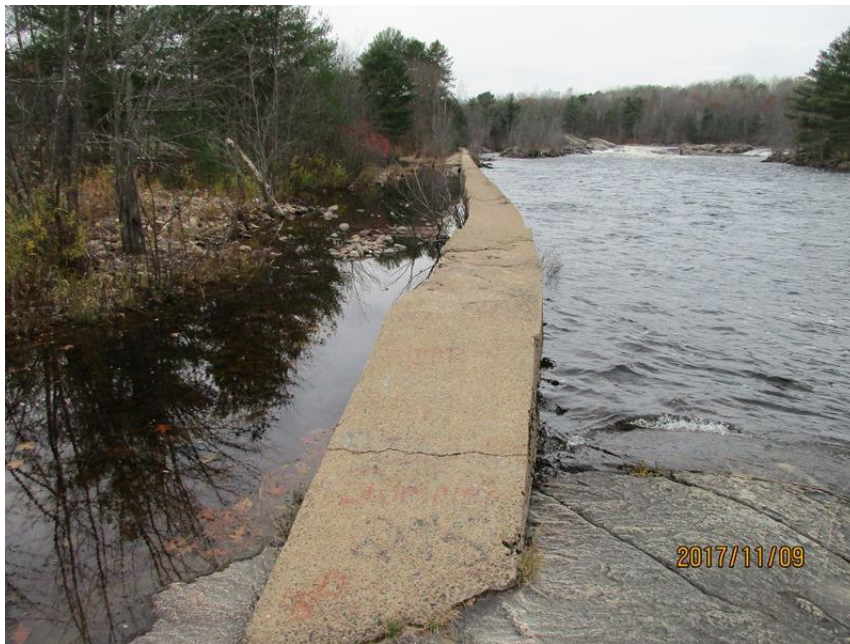
1 - The two walls to create the pond were built by town residents approximately 50 years ago. The west wall has a concrete base and an approximate 4 foot cemented and grouted rock wall on top. The wider concrete base on the rock wall does not extend the full length of the wall. The purpose of the walls was to create the pond and hold back the river flow. Over time, the park was enhanced with a walking/biking trail part of which is asphalt. The rock wall has an inflow to the pond and the other wall has an outflow structure

Rock Wall – Looking West from Island (shows partial foundation supporting wall)

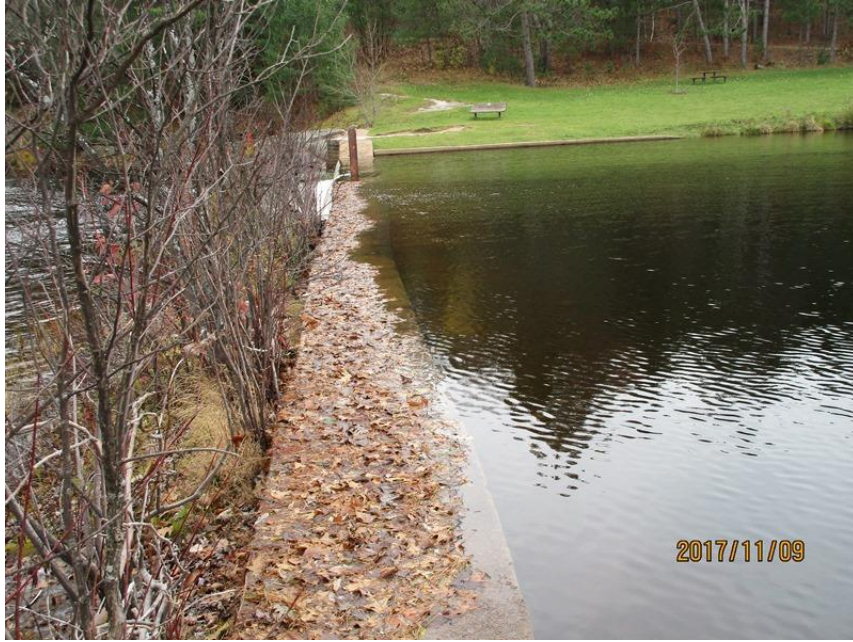
- 8** - On the date of the site visit, overtopping of the east concrete wall was prevalent.
- 9** - Use of the wall at dusk or dawn is not restricted.
- 10** - The two walls run approximately east and west and the sun angle can hinder a person's perception of distance and depth with the river water flowing alongside.

- 20** - The town does promote the park in its advertising but not the walls.
- 21** - There are no known survey records of the settlement of the walls. The east wall has a definitive slope to the discharge end and overtopping is prevalent at the time of inspection.

Outflow Wall – Looking South East (overtopping taken from Island)

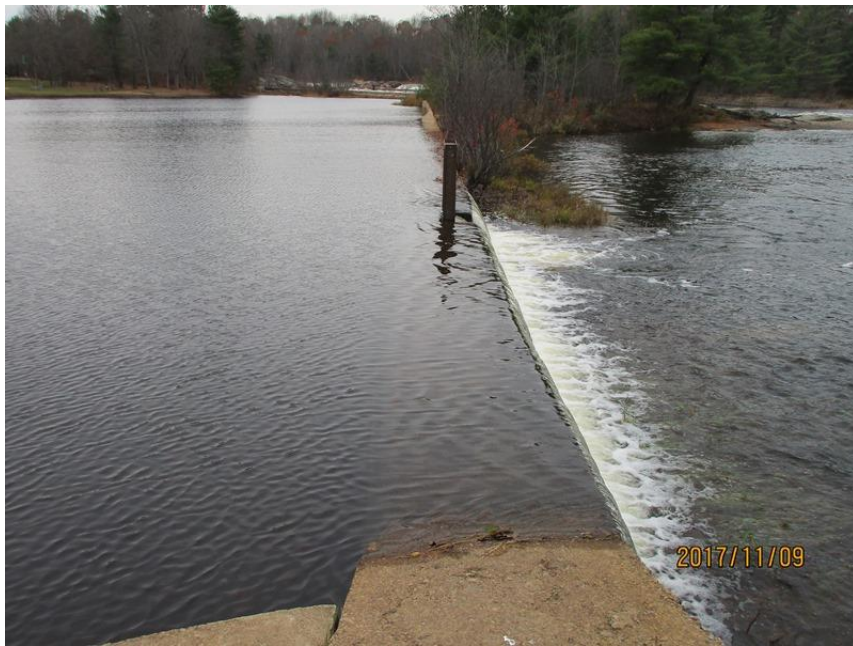
Outflow Wall – Looking North West (partially submerged structure)
